# US Liftboat Trinity II

## Engineering Design, Risk Assessment and Ethics

By  
Glen Stevick, Ph.D., P.E.  
Chelsea Torgersen-Bell  
Berkeley Engineering And Research, Inc.

May 27-29, 2016  
Society of Forensic Engineers and Scientists (SFES)  
Maritime Seminar, Emeryville, CA

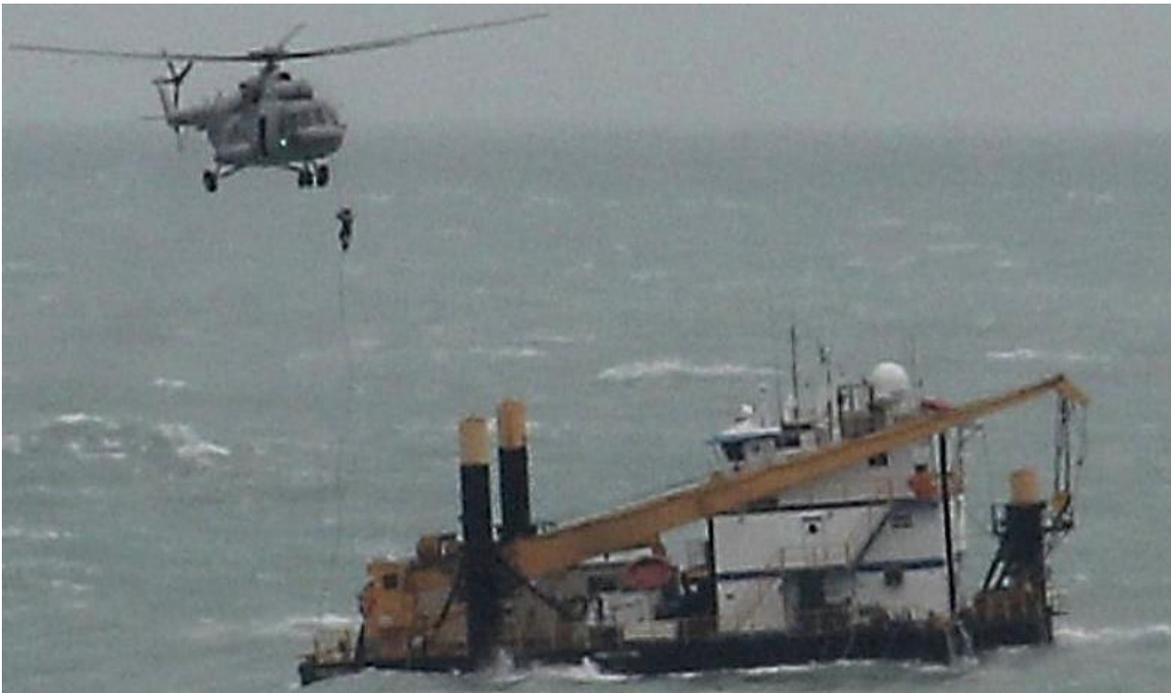
Photo of the adrift *Trinity II*, taken while Mexican Navy personnel boarded the vessel.

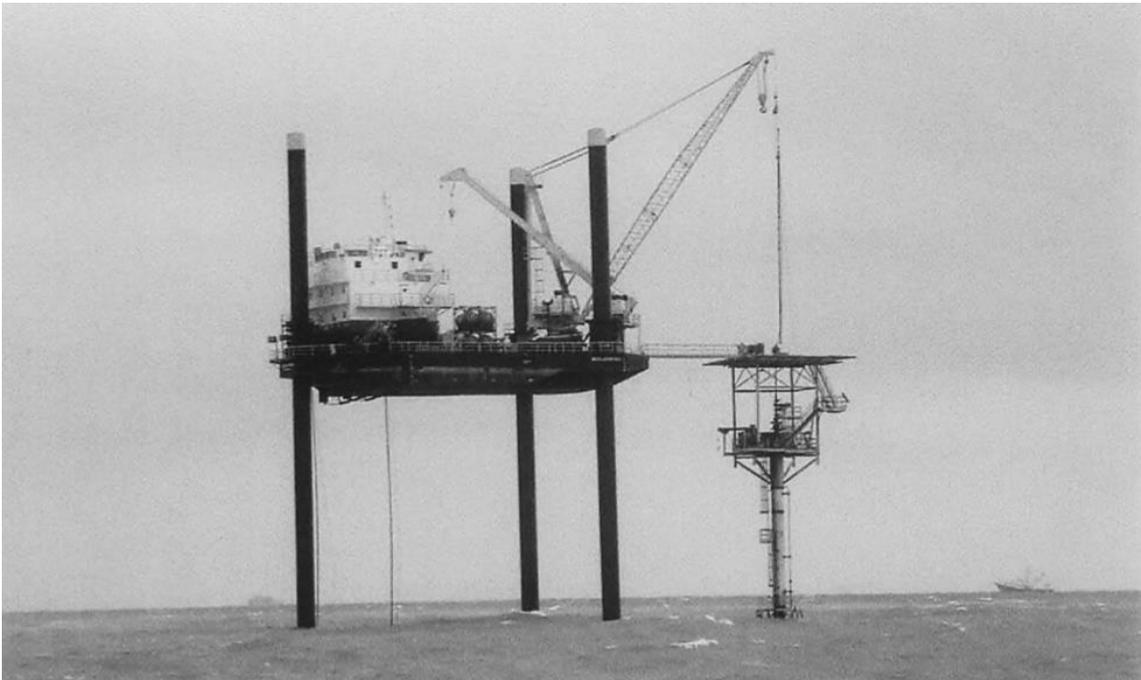
Figure 1. File photograph, provided by Company C, showing the *Trinity II* jacked up during operations.<sup>1</sup>

On Thursday, September 8, 2011 at about 12:00CDT the US Liftboat, *Trinity II*, experienced damage to the stern jacking leg from heavy weather associated with Hurricane Nate. The *Trinity II* had three jacking legs, one at the stern and two at the bow, one on each side, SEE Figure 1 below:
