# US Liftboat Trinity II

## Engineering Design, Risk Assessment and Ethics

By  
Glen Stevick, Ph.D., P.E.  
Chelsea Torgersen-Bell  
Berkeley Engineering And Research, Inc.

May 27-29, 2016  
Society of Forensic Engineers and Scientists (SFES)  
Maritime Seminar, Emeryville, CA

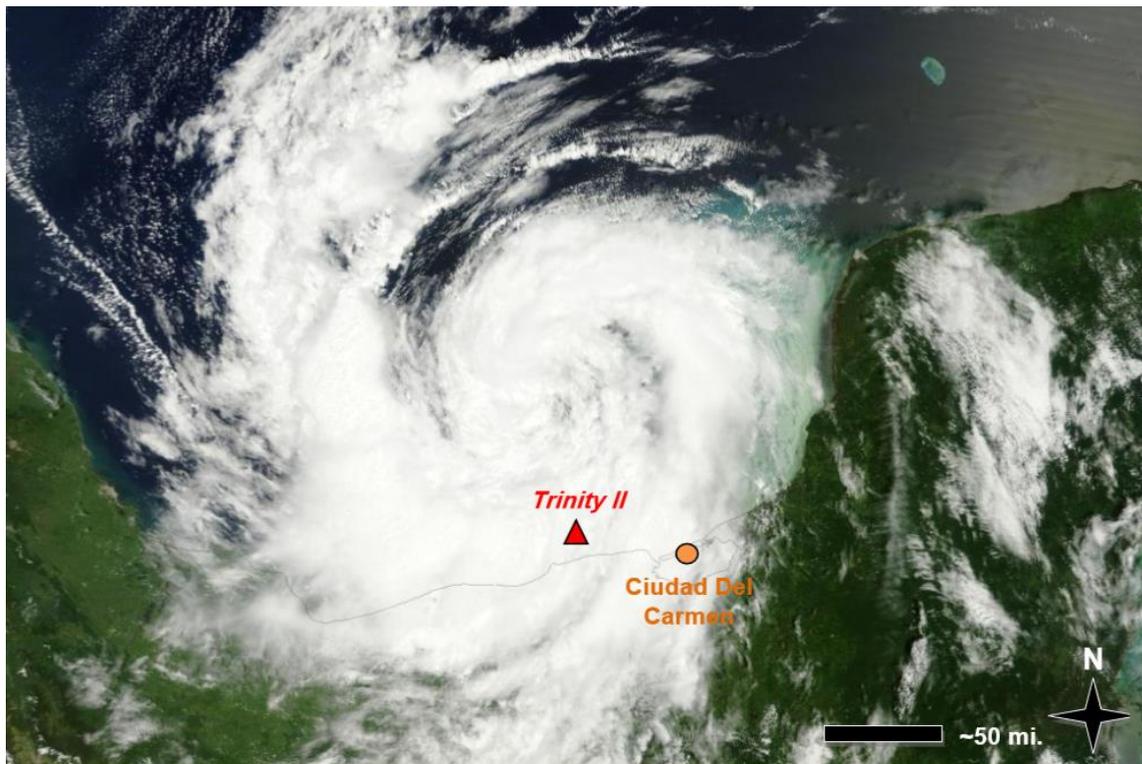
On Thursday, September 8, 2011 at about 12:00CDT, the *Trinity II* experienced damage to the stern jacking leg from heavy weather associated with Hurricane Nate. A satellite image of Hurricane Nate, September 9, 2011, is shown in Figure 3 below:

Figure 3. Satellite image by the National Aeronautics and Space Administration (NASA), Tropical Storm Nate over the Bay of Campeche, September 9, 2011.

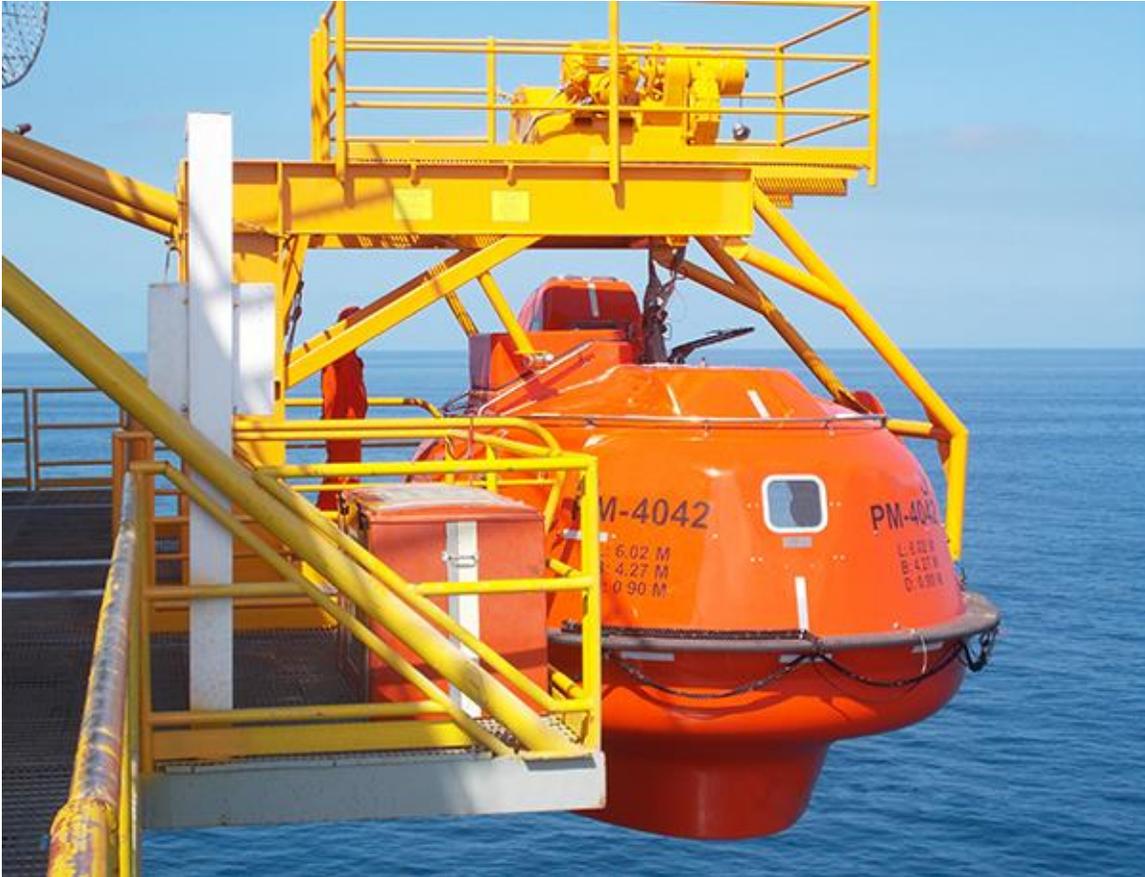
Figure 5. Capsule style lifeboats exhibited on Survival Systems International's website since 2009.<sup>30</sup>

The evacuation plan should also have prescribed the setting up of guide/safety lines from the liftboat main cabin to the TEMPSC's as a storm worsens.
